## Annual Inspection

Mid Suffolk District Council

Stonham Parva

Inspection Ref: 1437420

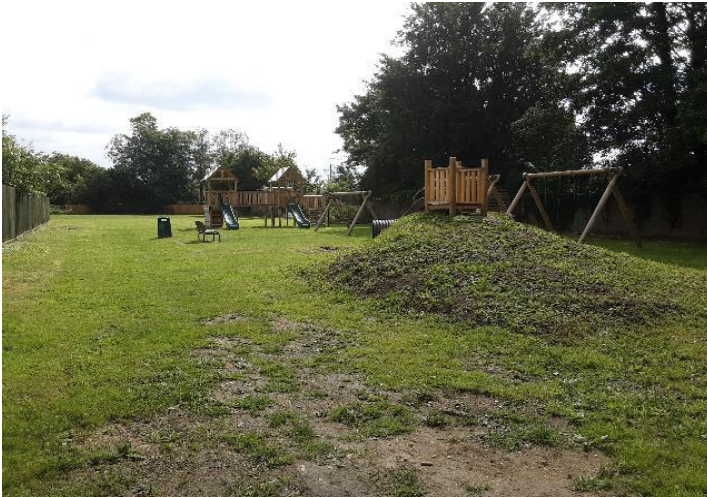
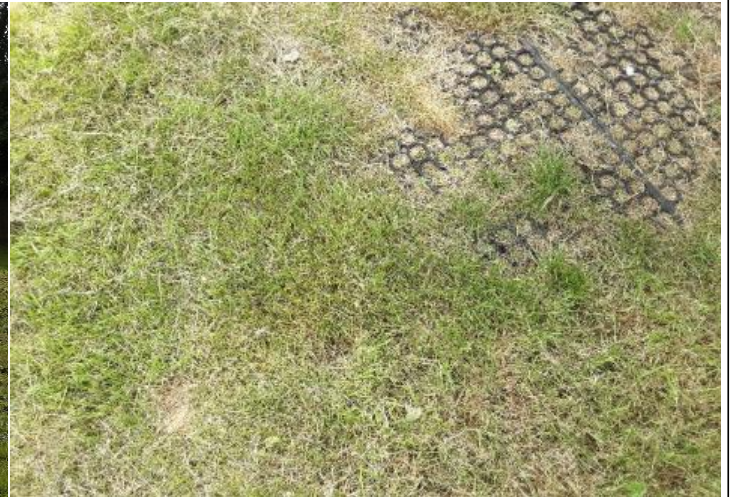
### 8 - Low Risk (Finding 1)

The grass mats are silted up and the soil is compacted; this may have an effect on the impact absorbing properties of the surface - Consider HIC testing impact absorbing properties to ensure the correct surface qualities are maintained for the equipment and replace as required

**Finding:** The grass mats are silted up and the soil is compacted; this may have an effect on the impact absorbing properties of the surface

**Action:** Consider HIC testing impact absorbing properties to ensure the correct surface qualities are maintained for the equipment and replace as required

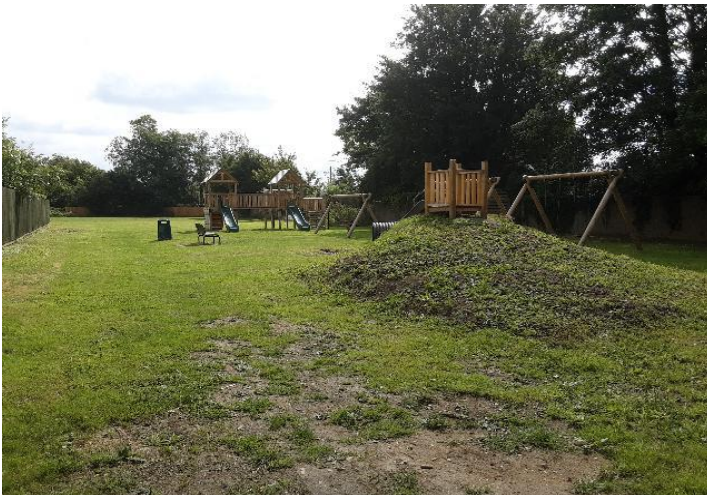
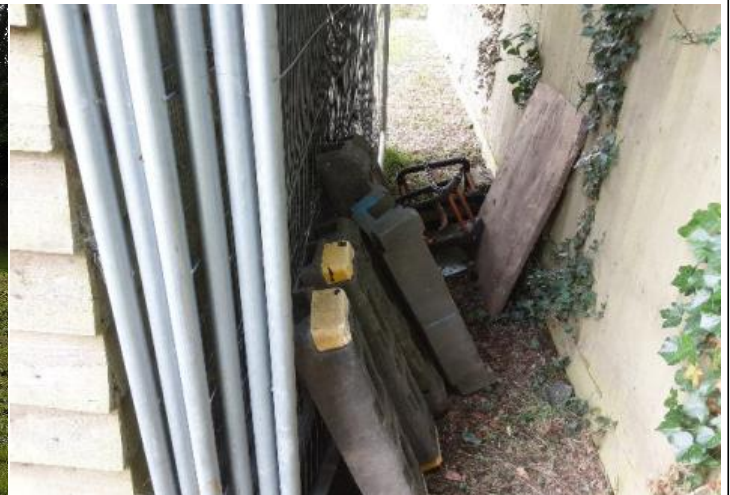
### 8 - Low Risk (Finding 2)

Heras fencing and playground spares have been placed behind the shelter - Provide an alternative secure location for the items

**Finding:** Heras fencing and playground spares have been placed behind the shelter

**Action:** Provide an alternative secure location for the items

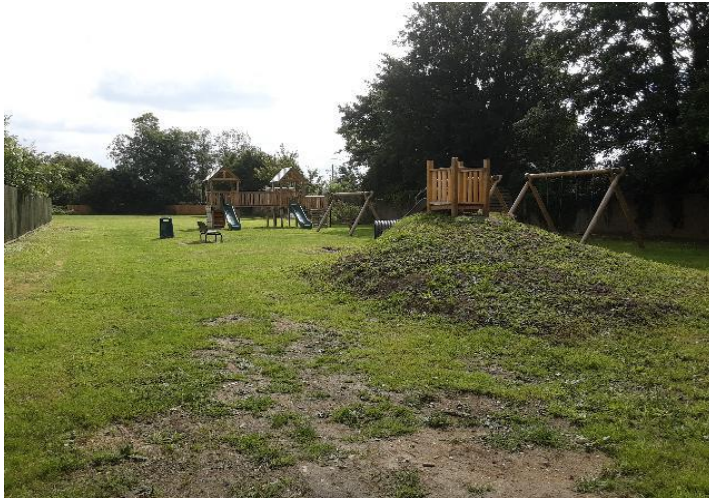
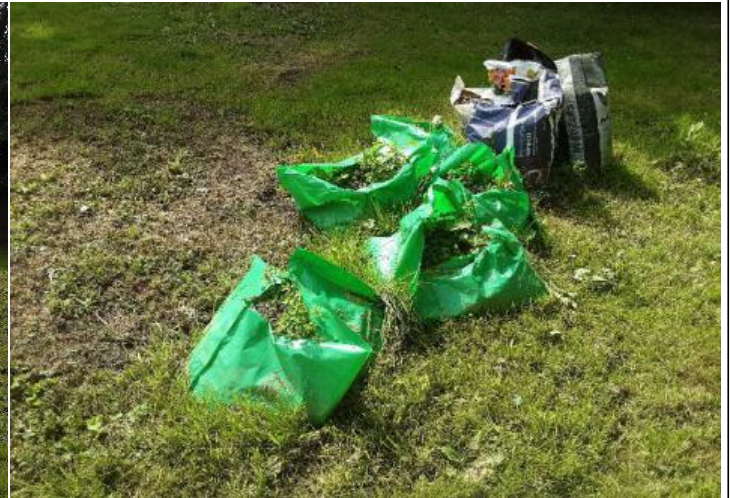
**i** 8 - Low Risk (Finding 3)

General waste has been left on site - Arrange removal of waste from site

**Finding:** General waste has been left on site

**Action:** Arrange removal of waste from site

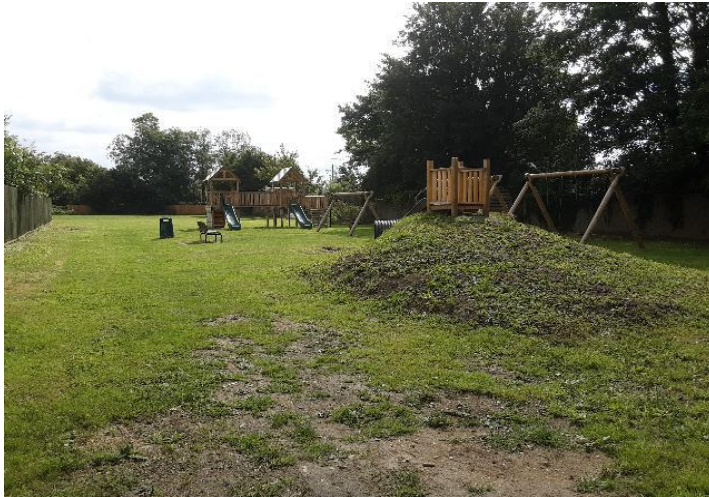
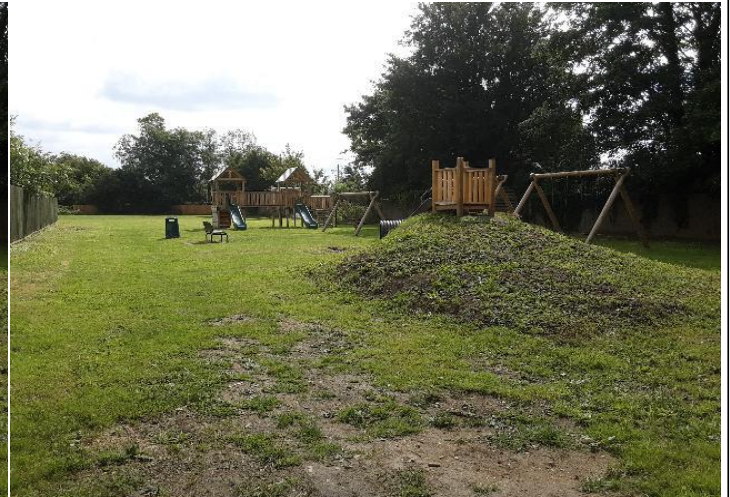
**i** 5 - Very Low Risk (Finding 1)

It is recommended that signage, with information including the site address, contact information for maintenance issues and emergency contact details are provided for the facility - Provide in accordance with the recommendations

**Finding:** It is recommended that signage, with information including the site address, contact information for maintenance issues and emergency contact details are provided for the facility

**Action:** Provide in accordance with the recommendations

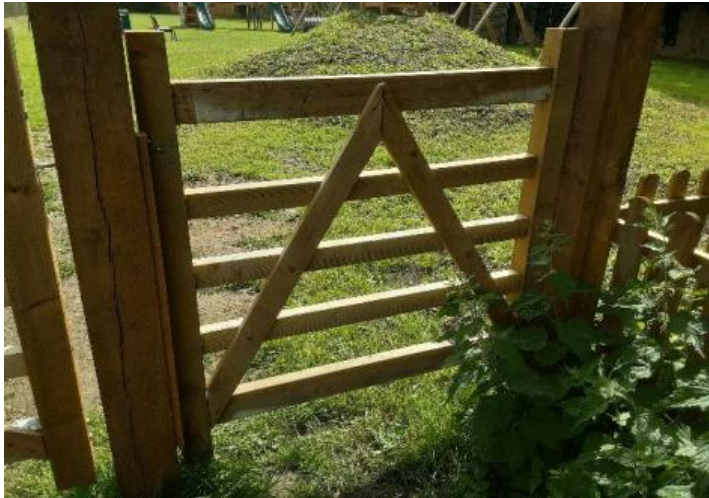
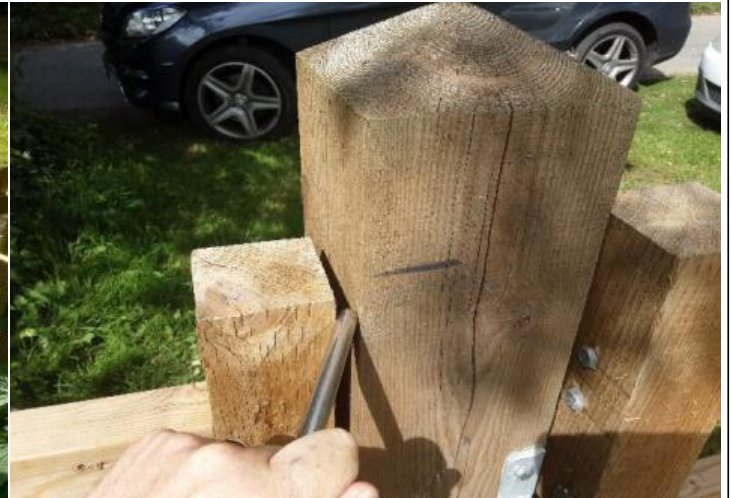
**i** 8 - Low Risk (Finding 1)

There are openings that are less than 12mm that could trap or crush fingers - Where possible a 12mm gap should be maintained on both sides or between the gate leaves

**Finding:** There are openings that are less than 12mm that could trap or crush fingers

**Action:** Where possible a 12mm gap should be maintained on both sides or between the gate leaves

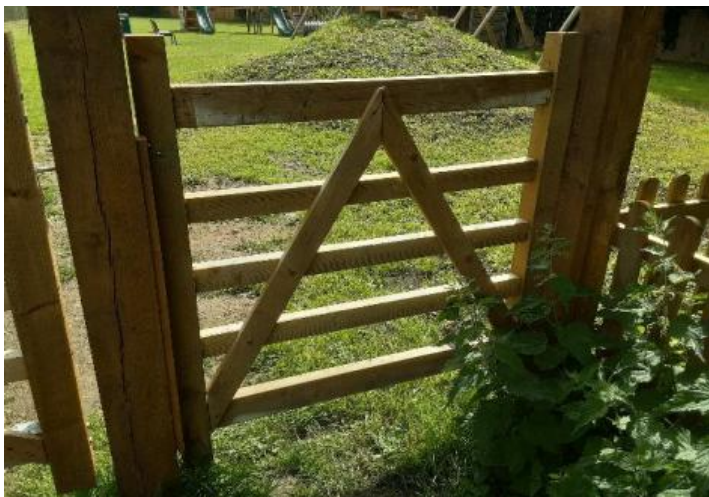
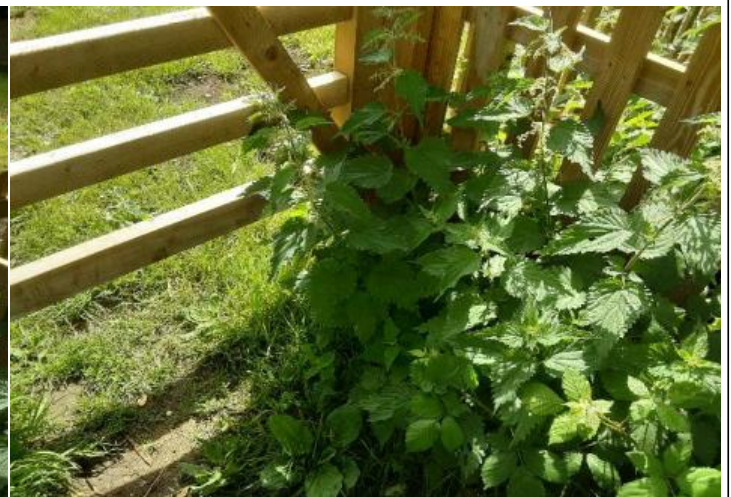
**i** 6 - Low Risk (Finding 2)

There is nettle growth around the gate - Remove the nettles

**Finding:** There is nettle growth around the gate

**Action:** Remove the nettles

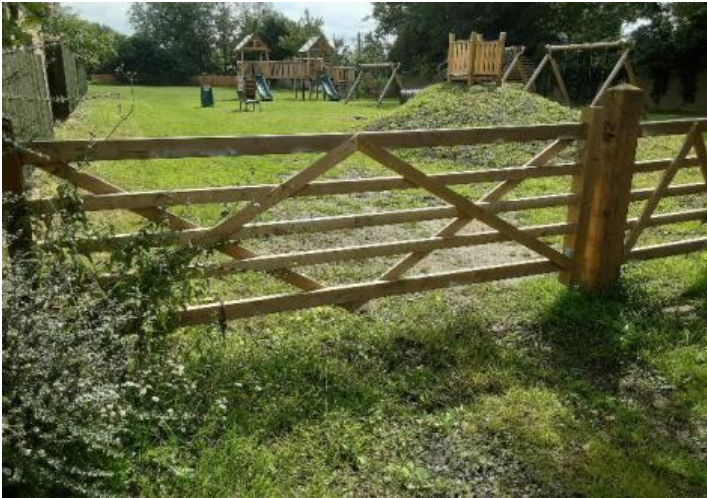
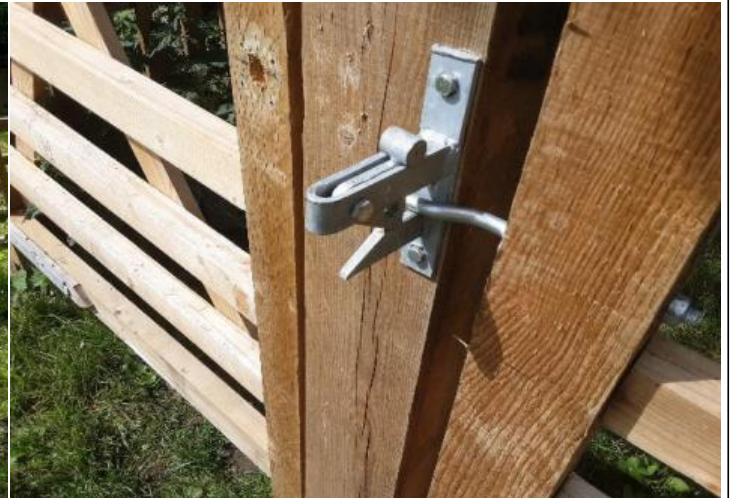
**i** 6 - Low Risk (Finding 1)

There is no padlock on the maintenance gate - Provide a padlock to secure the gate

**Finding:** There is no padlock on the maintenance gate

**Action:** Provide a padlock to secure the gate

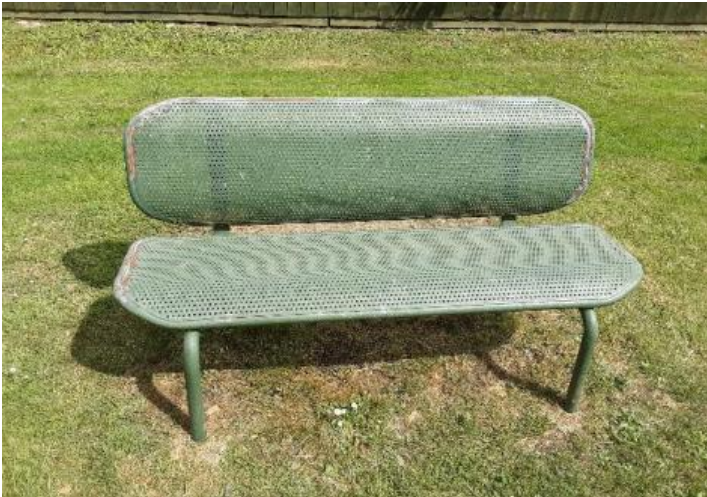
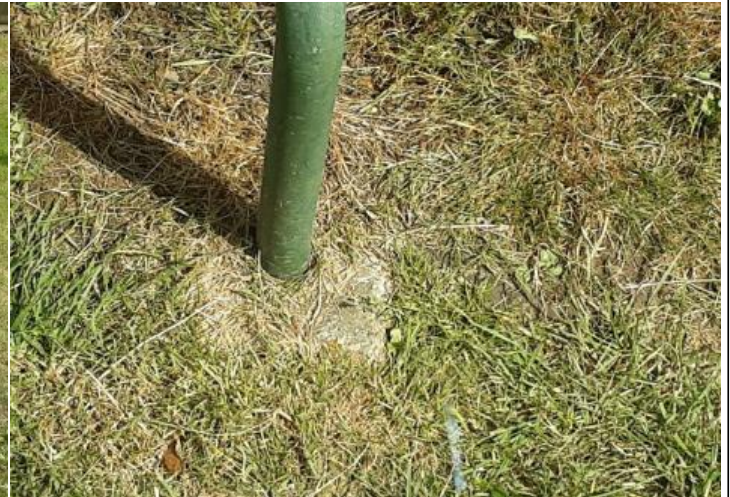
**i** 8 - Low Risk (Finding 1)

The surface has eroded and the foundations are exposed -  
Reinstate surrounding surfaces to cover the foundations

**Finding:** The surface has eroded and the foundations are exposed

**Action:** Reinstate surrounding surfaces to cover the foundations

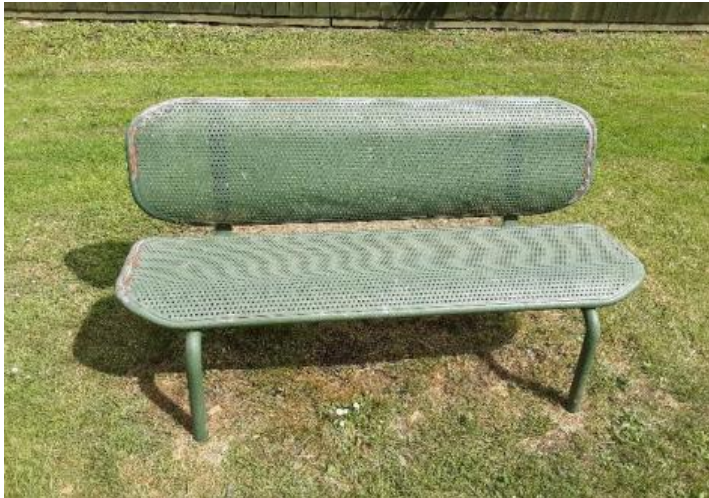
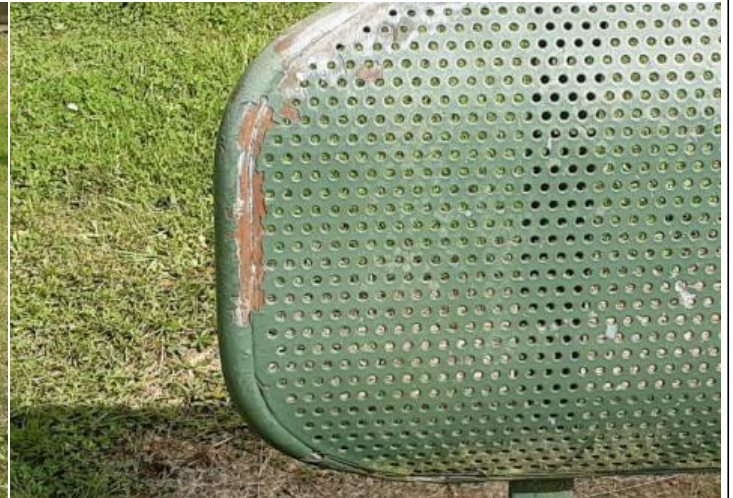
**i** 6 - Low Risk (Finding 2)

The paintwork on this item has been damaged or worn  
exposing the metal underneath which is rusting - Treat any  
rusting components and repaint

**Finding:** The paintwork on this item has been damaged or worn exposing the metal underneath which is rusting

**Action:** Treat any rusting components and repaint

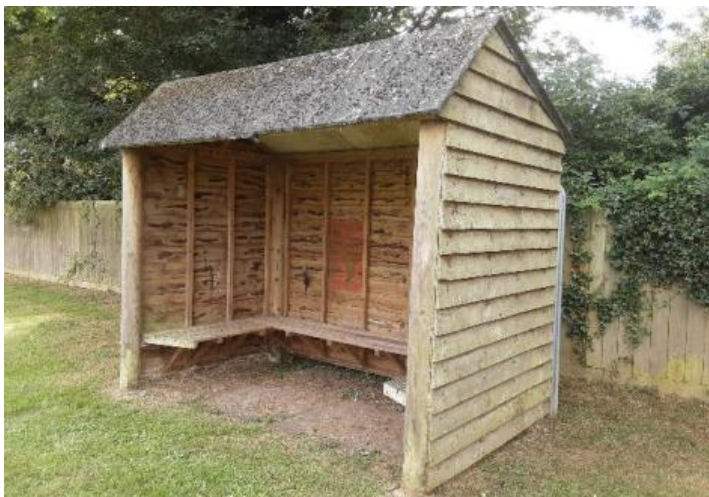
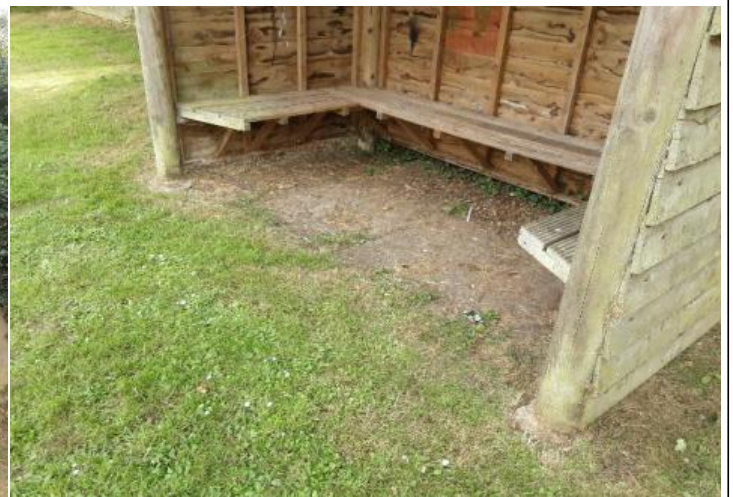
**i** 8 - Low Risk (Finding 1)

The area around the item has eroded and may become slippery - Reinstate eroded area

**Finding:** The area around the item has eroded and may become slippery

**Action:** Reinstate eroded area

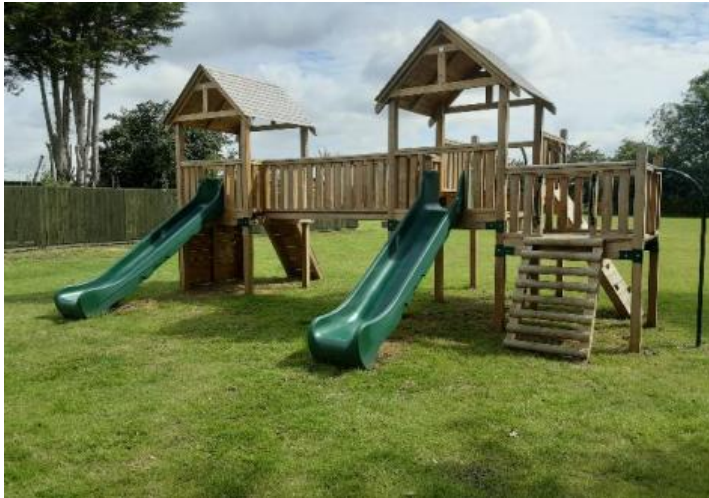
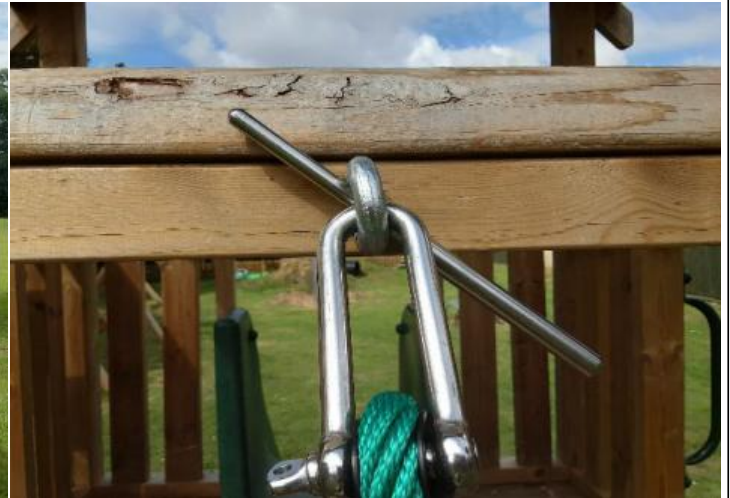
**i** 5 - Very Low Risk (Finding 1)

The connecting links are in excess of 8.6mm and less than 12mm and fail the requirements of BS EN 1176 Part 1; clause 4.2.13, Chains - Monitor use and replace with compliant links at the next maintenance cycle

**Finding:** The connecting links are in excess of 8.6mm and less than 12mm and fail the requirements of BS EN 1176 Part 1; clause 4.2.13, Chains

**Action:** Monitor use and replace with compliant links at the next maintenance cycle

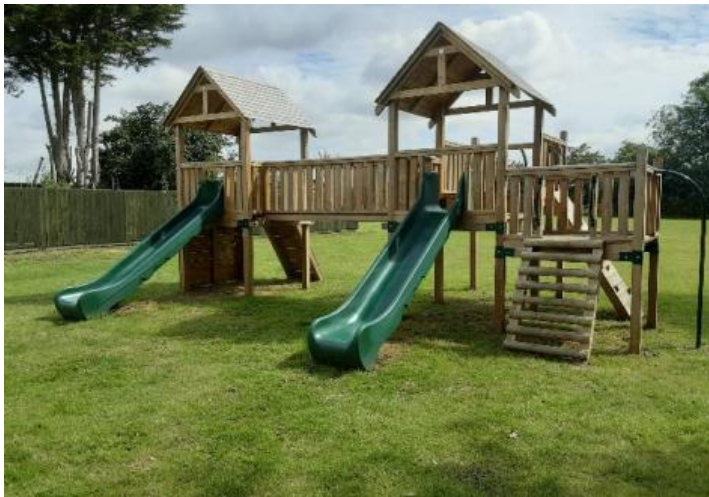
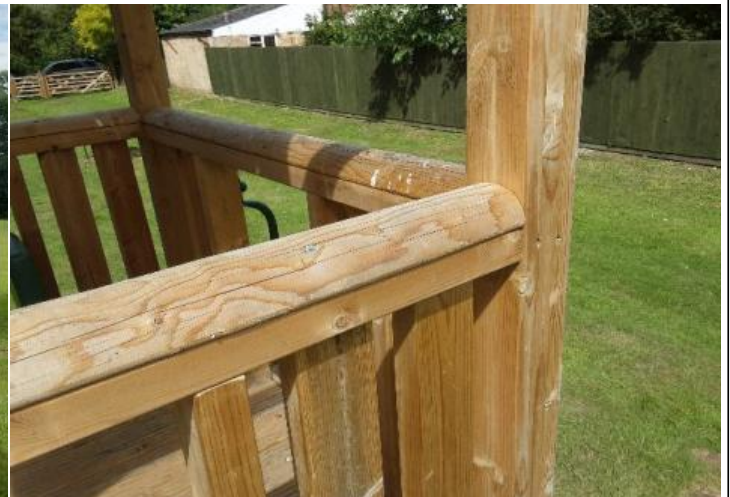
**i** 4 - Very Low Risk (Finding 2)

The design of the barriers encourages standing or sitting and fails the requirements of BS EN 1176 - Monitor - No remedial work recommended

**Finding:** The design of the barriers encourages standing or sitting and fails the requirements of BS EN 1176

**Action:** Monitor - No remedial work recommended

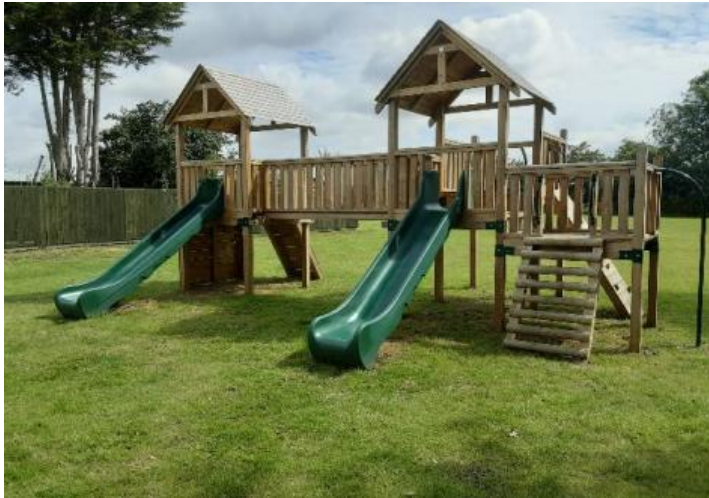
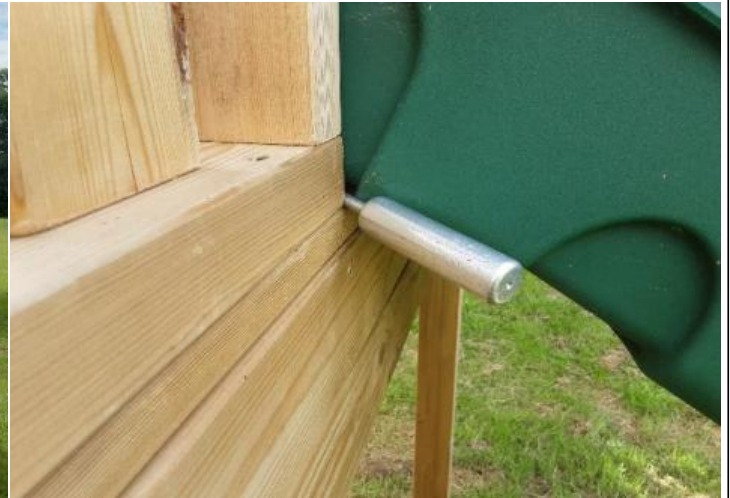
**i** 5 - Very Low Risk (Finding 3)

There is/are finger entrapment/s in the structure and the item fails to meet the requirements of BS EN 1176 Part 1 4.2.7.6 Entrapment of fingers - Monitor - No remedial work recommended

**Finding:** There is/are finger entrapment/s in the structure and the item fails to meet the requirements of BS EN 1176 Part 1 4.2.7.6 Entrapment of fingers

**Action:** Monitor - No remedial work recommended

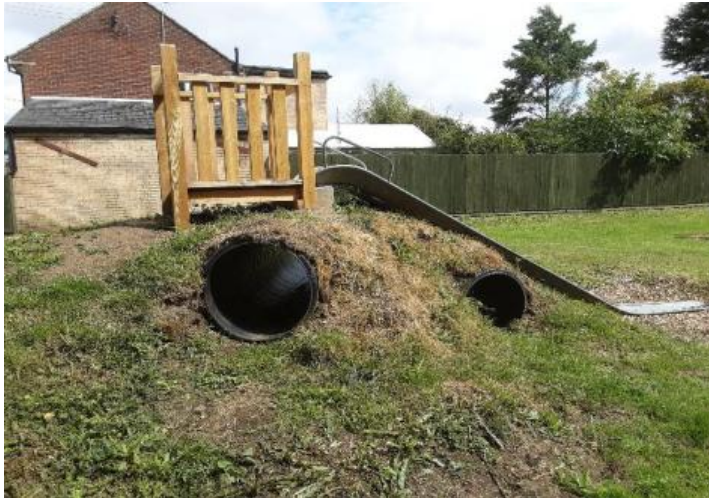
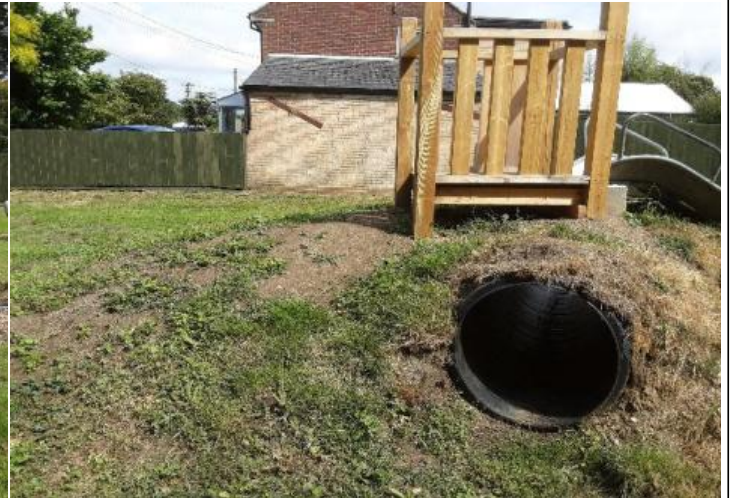
**i** 8 - Low Risk (Finding 1)

This design / configuration of tunnel mound is well established and has been successfully included in large quantities of playgrounds throughout the UK. Whilst the design does not fully meet the requirements of BS EN 1176 with regards to falls in excess of 600mm over the edge of the tunnel to the surface below, it has been risk assessed as fit for purpose and no changes are recommended to the design - Monitor - No remedial work recommended

**Finding:** This design / configuration of tunnel mound is well established and has been successfully included in large quantities of playgrounds throughout the UK. Whilst the design does not fully meet the requirements of BS EN 1176 with regards to falls in excess of 600mm over the edge of the tunnel to the surface below, it has been risk assessed as fit for purpose and no changes are recommended to the design

**Action:** Monitor - No remedial work recommended

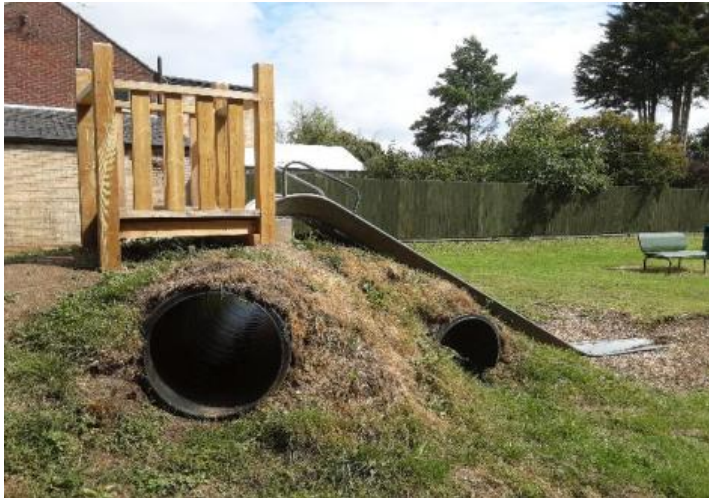
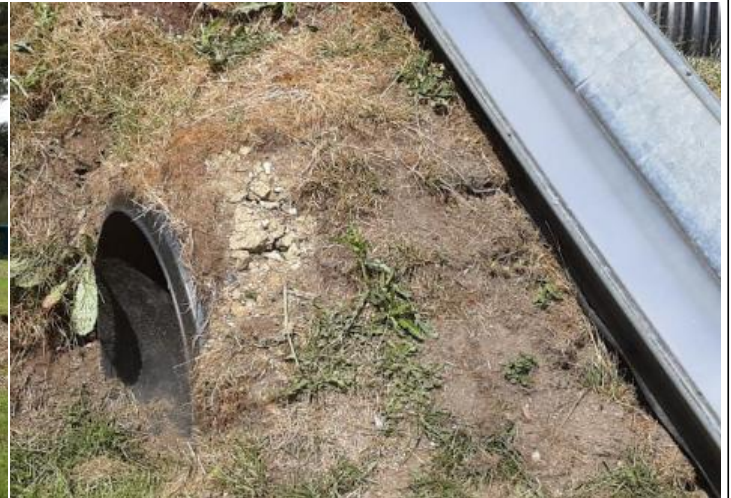
**i** 8 - Low Risk (Finding 1)

The concrete over the crawling tunnel forms a hard object within the falling space of the equipment in contravention of the requirements of BS EN 1176 Part 1 - Reinstate to cover the concrete

**Finding:** The concrete over the crawling tunnel forms a hard object within the falling space of the equipment in contravention of the requirements of BS EN 1176 Part 1  
**Action:** Reinstate to cover the concrete

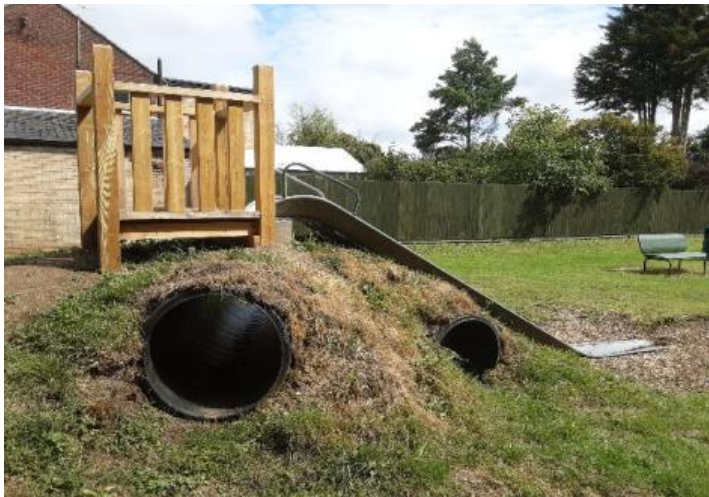
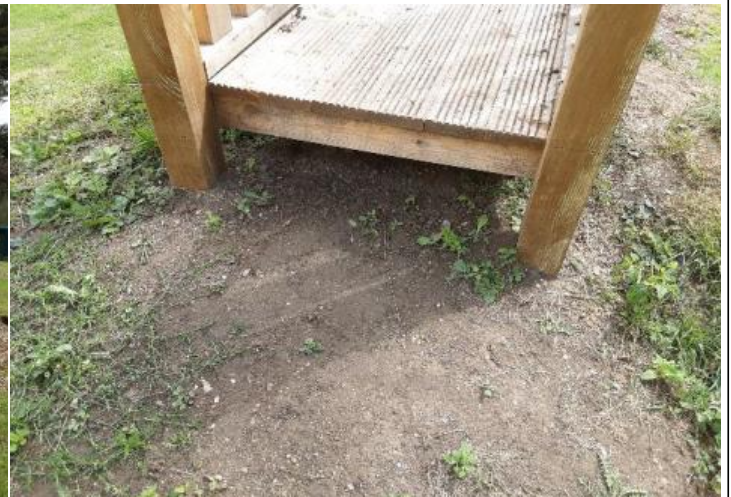
**i** 8 - Low Risk (Finding 2)

The area around the item has eroded and may become slippery - Reinstate eroded area

**Finding:** The area around the item has eroded and may become slippery  
**Action:** Reinstate eroded area

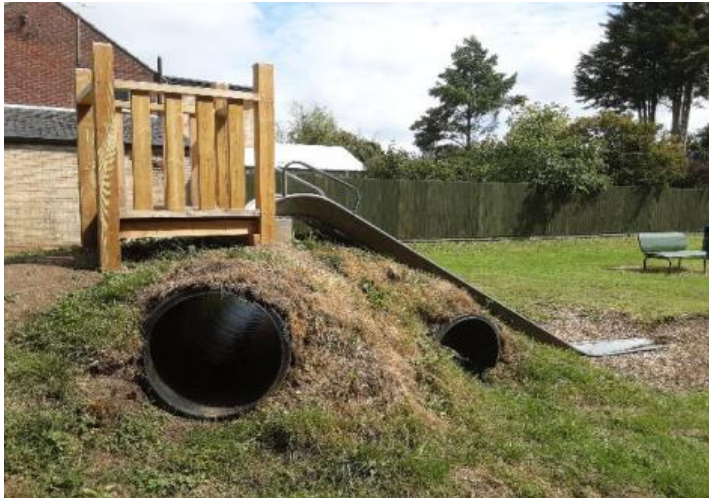
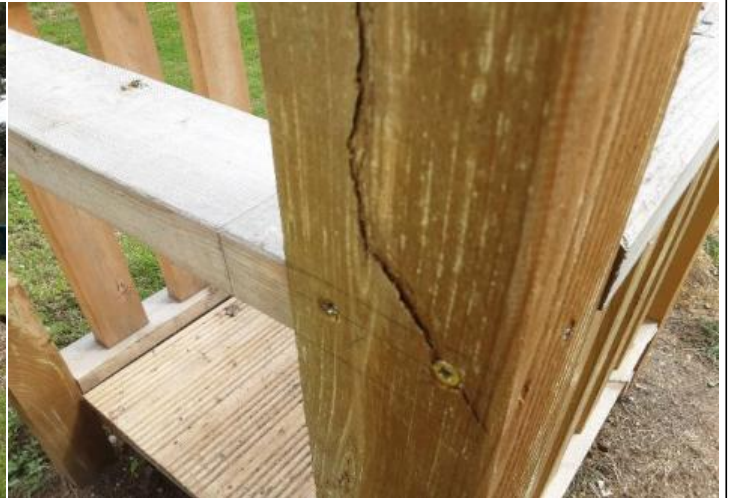
**i** 6 - Low Risk (Finding 3)

Parts of the timber are rough or splintered - Remove all rough or sharp edges

**Finding:** Parts of the timber are rough or splintered

**Action:** Remove all rough or sharp edges

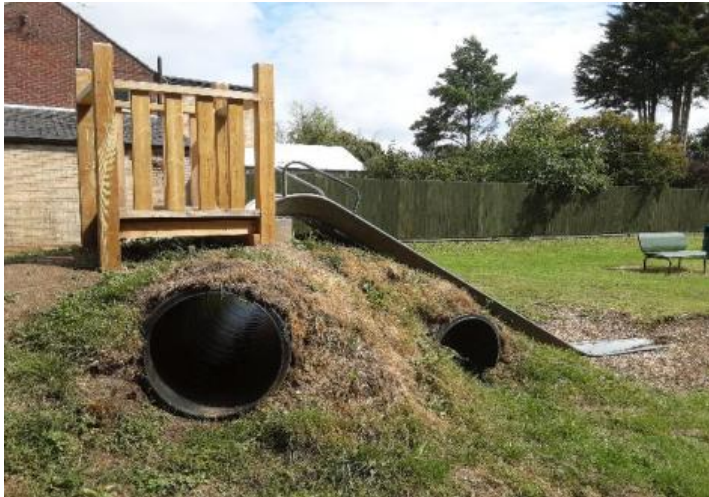
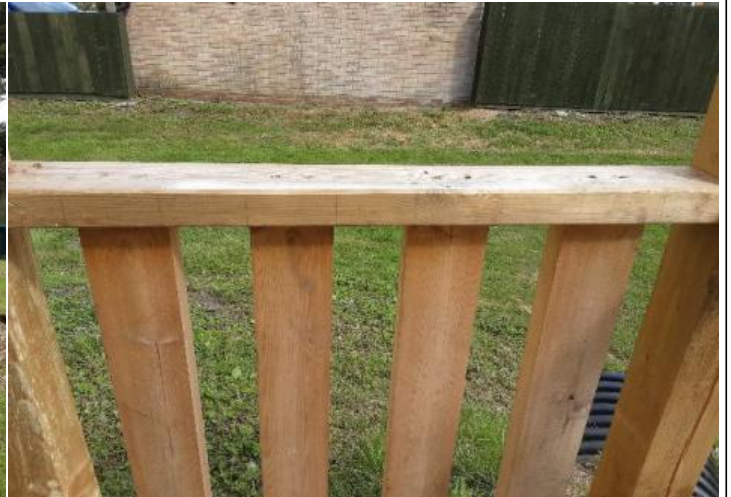
**i** 4 - Very Low Risk (Finding 4)

The design of the barriers encourages standing or sitting and fails the requirements of BS EN 1176 - Monitor - No remedial work recommended

**Finding:** The design of the barriers encourages standing or sitting and fails the requirements of BS EN 1176

**Action:** Monitor - No remedial work recommended
