## Annual Inspection

Mid Suffolk District Council

Stonham Parva

Inspection Ref: 1437420

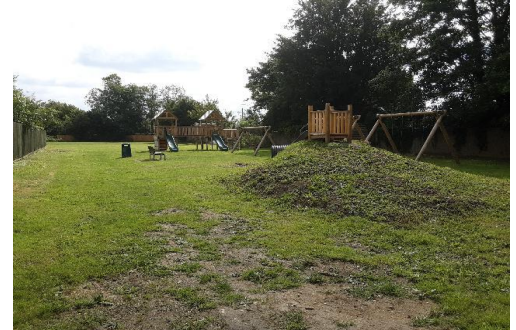
**Item:** Site General  
**Manufacturer:** Owner/Operator  
**Surface Type:** N/A  
**Item Quantity:** 1  
**Equipment Compliance:** N/A  
**Surface Area Compliance:** N/A

The grass mats are silted up and the soil is compacted; this may have an effect on the impact absorbing properties of the surface - Consider HIC testing impact absorbing properties to ensure the correct surface qualities are maintained for the equipment and replace as required

**Action:** Consider HIC testing impact absorbing properties to ensure the correct surface qualities are maintained for the equipment and replace as required

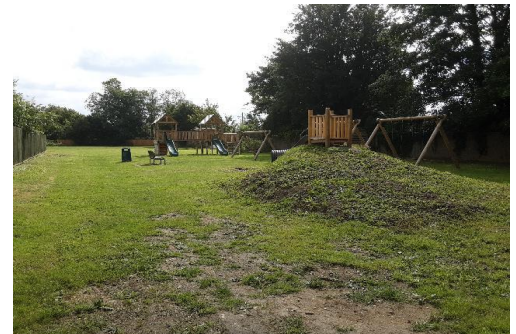
**Item:** Sign  
**Manufacturer:** Not Applicable  
**Surface Type:** N/A  
**Item Quantity:** 1  
**Equipment Compliance:** N/A  
**Surface Area Compliance:** N/A

It is recommended that signage, with information including the site address, contact information for maintenance issues and emergency contact details are provided for the facility - Provide in accordance with the recommendations

**Action:** Provide in accordance with the recommendations

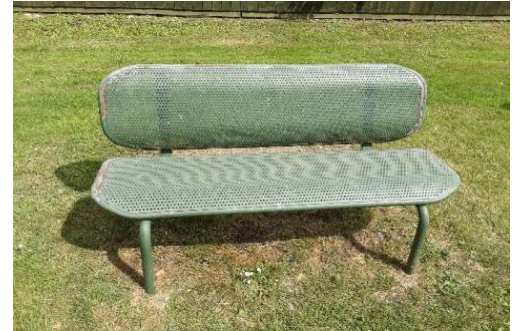
**Item:** Bench  
**Manufacturer:** Owner/Operator  
**Surface Type:** N/A  
**Item Quantity:** 1  
**Equipment Compliance:** N/A  
**Surface Area Compliance:** N/A

The surface has eroded and the foundations are exposed -  
Reinstate surrounding surfaces to cover the foundations

The paintwork on this item has been damaged or worn  
exposing the metal underneath which is rusting - Treat any  
rusting components and repaint

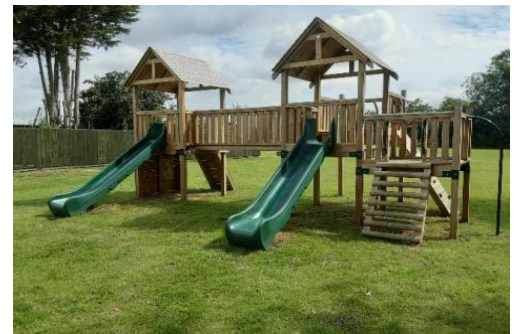
**Item:** Multi Play (Junior)  
**Manufacturer:** Sovereign Leisure  
**Surface Type:** Grass Matrix Tiles  
**Item Quantity:** 1  
**Equipment Compliance:** No  
**Surface Area Compliance:** Yes

The connecting links are in excess of 8.6mm and less than 12mm and fail the requirements of BS EN 1176 Part 1; clause 4.2.13, Chains - Monitor use and replace with compliant links at the next maintenance cycle

The design of the barriers encourages standing or sitting and fails the requirements of BS EN 1176 - Monitor - No remedial work recommended

There is/are finger entrapment/s in the structure and the item fails to meet the requirements of BS EN 1176 Part 1 4.2.7.6 Entrapment of fingers - Monitor - No remedial work recommended

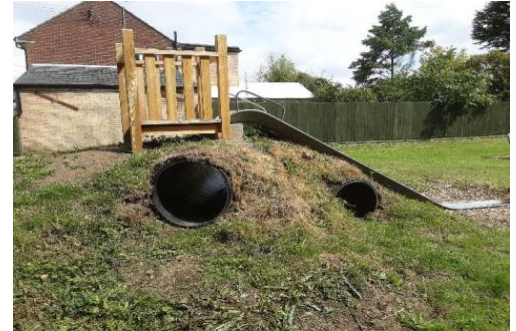
**Item:** Crawling Tunnel  
**Manufacturer:** Not Identified  
**Surface Type:** Grass  
**Item Quantity:** 1  
**Equipment Compliance:** Yes  
**Surface Area Compliance:** Yes

This design / configuration of tunnel mound is well established and has been successfully included in large quantities of playgrounds throughout the UK. Whilst the design does not fully meet the requirements of BS EN 1176 with regards to falls in excess of 600mm over the edge of the tunnel to the surface below, it has been risk assessed as fit for purpose and no changes are recommended to the design - Monitor - No remedial work recommended

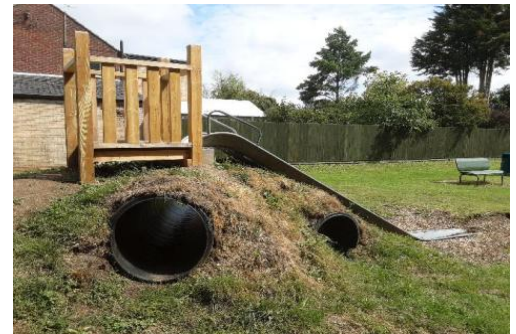
**Item:** Embankment Slide  
**Manufacturer:** Not Identified  
**Surface Type:** Bark Mulch  
**Item Quantity:** 1  
**Equipment Compliance:** No  
**Surface Area Compliance:** Yes

The design of the barriers encourages standing or sitting and fails the requirements of BS EN 1176 - Monitor - No remedial work recommended
